FIFA Quality Programme for Football Turf

FIFA LABORATORY TEST REPORT

Product name	Stemgrass 60-14 PU
Product type (Field/Lines)	Field
FIFA Licensee	CoCreation Grass Corporation, Ltd.
FIFA accredited Test Institute	Sports Labs Ltd.

Laboratory Test report number	17254/2854
Date of test	25.10.2016

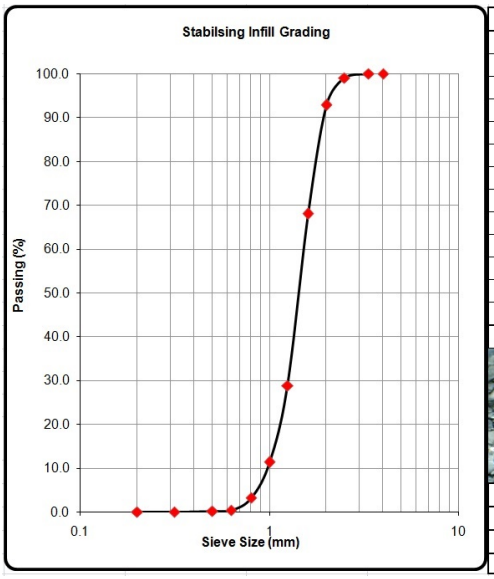
5.7.2 a) Performance infill particle grading curve

SIEVE SIZE (mm)	PASSING %
4.000	100.0
3.350	100.0
2.500	99.0
2.000	92.8
1.600	68.0
1.250	28.7
1.000	11.3
0.800	3.2
0.630	0.4
0.500	0.1
0.315	0.0
0.200	0.0
Passing to base tray	0.0

PARTICLE SHAPE DESIGNATION	
A2	
BULK DENSITY	
0.430	Mg/m³

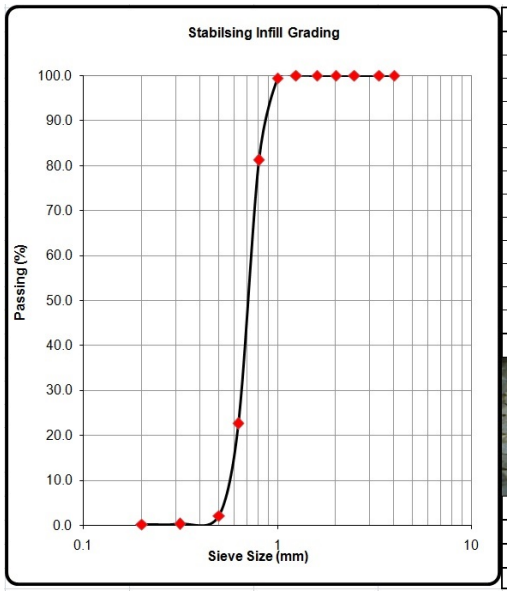
5.7.2 b) Stabilising infill particle grading curve

SIEVE SIZE (mm)	PASSING %
4.000	100.0
3.350	100.0
2.500	100.0
2.000	100.0
1.600	100.0
1.250	100.0
1.000	99.4
0.800	81.2
0.630	22.5
0.500	2.1
0.315	0.2
0.200	0.1
Passing to base tray	0.0

PARTICLE SHAPE DESIGNATION	
B2	
BULK DENSITY	
1.544	Mg/m³

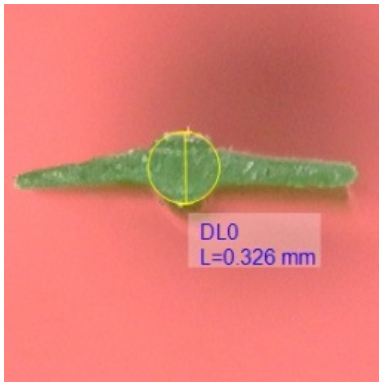
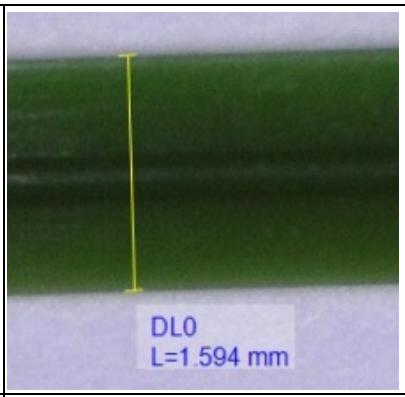
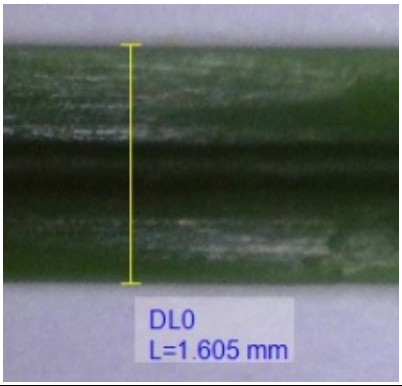
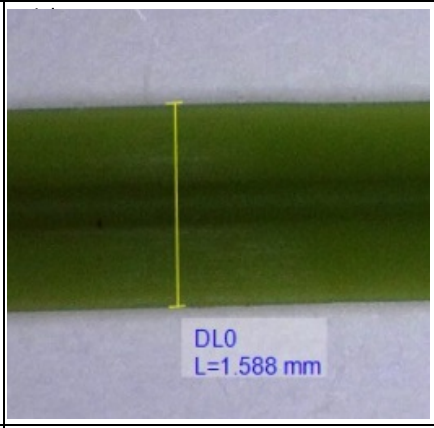
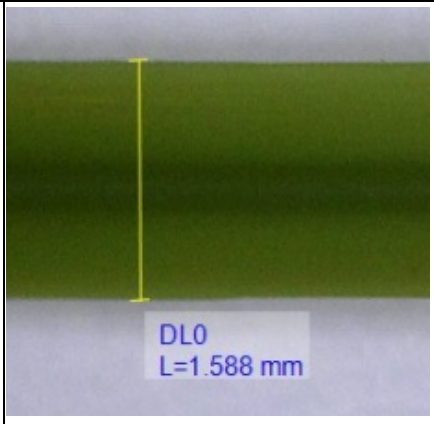
5.7.5 Yarn characteristics

Emerald yarn - 326 micron, 1.6 mm, circle diameter 326 micron, Olive yarn - 334 micron, 1.6 mm, circle diameter 334 mic
